DEPARTMENT OF NATURAL RESOURCES
DIVISION OF OIL, GAS AND MINING

RE: Site Inspection, Thirstystone Resources, Inc., Black Ridge #1, S/053/027, Washington County, Utah

Date of Inspection: October 17, 2002
Time of Inspection: 11:00 a.m.
Conditions: Warm
Participants: Doug Jensen, DOGM

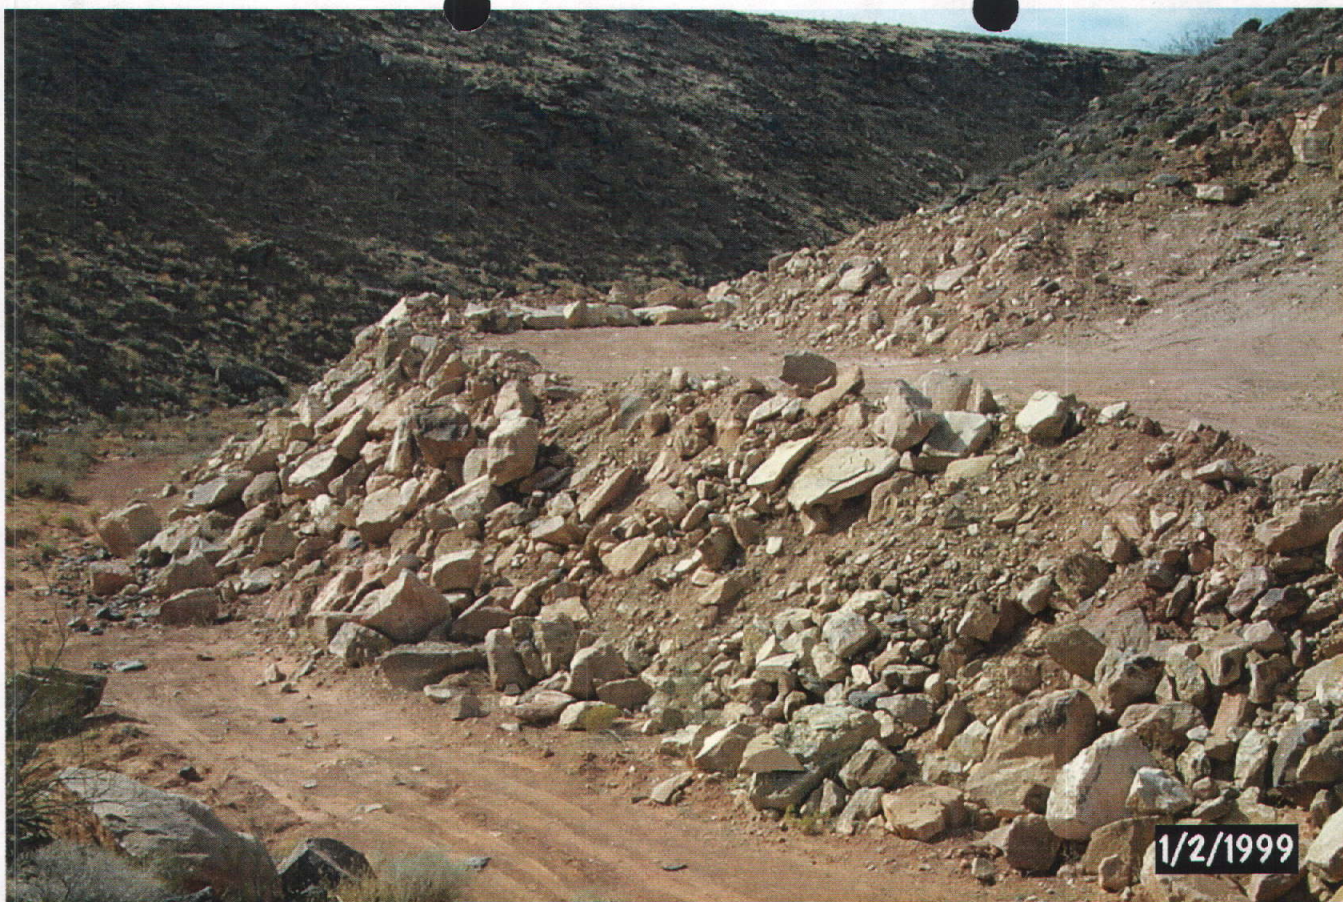
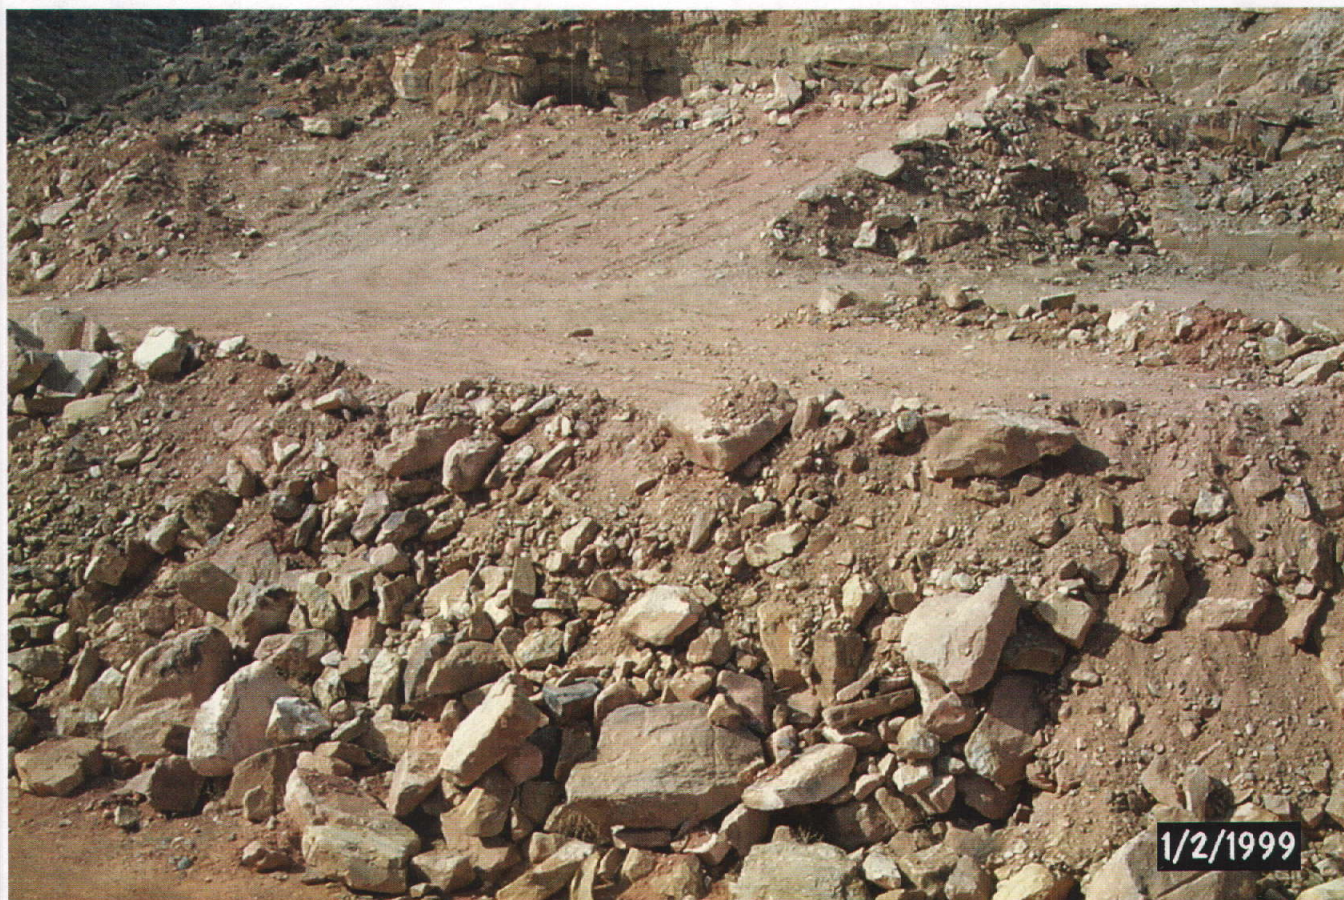
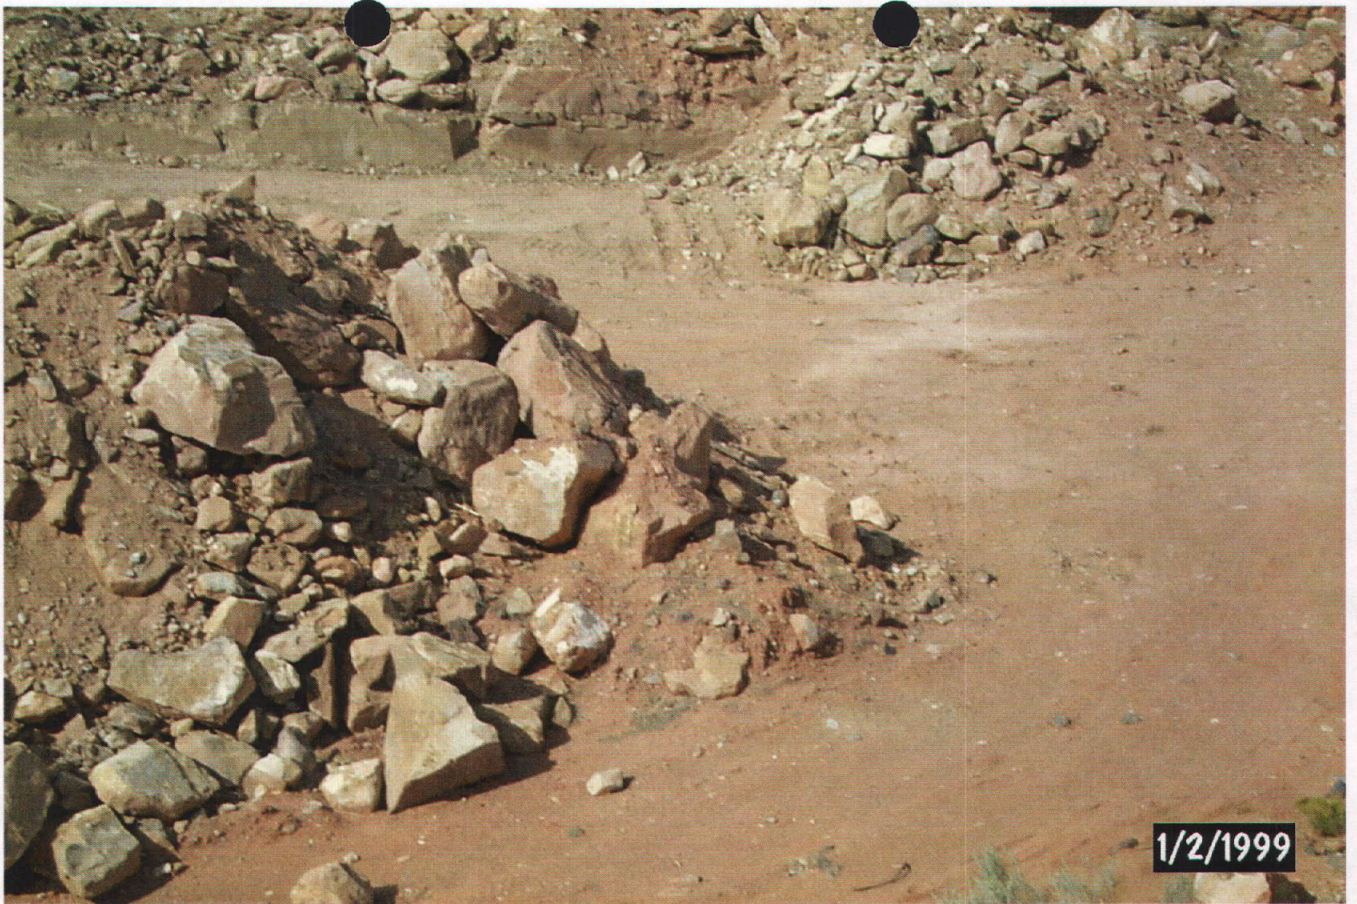
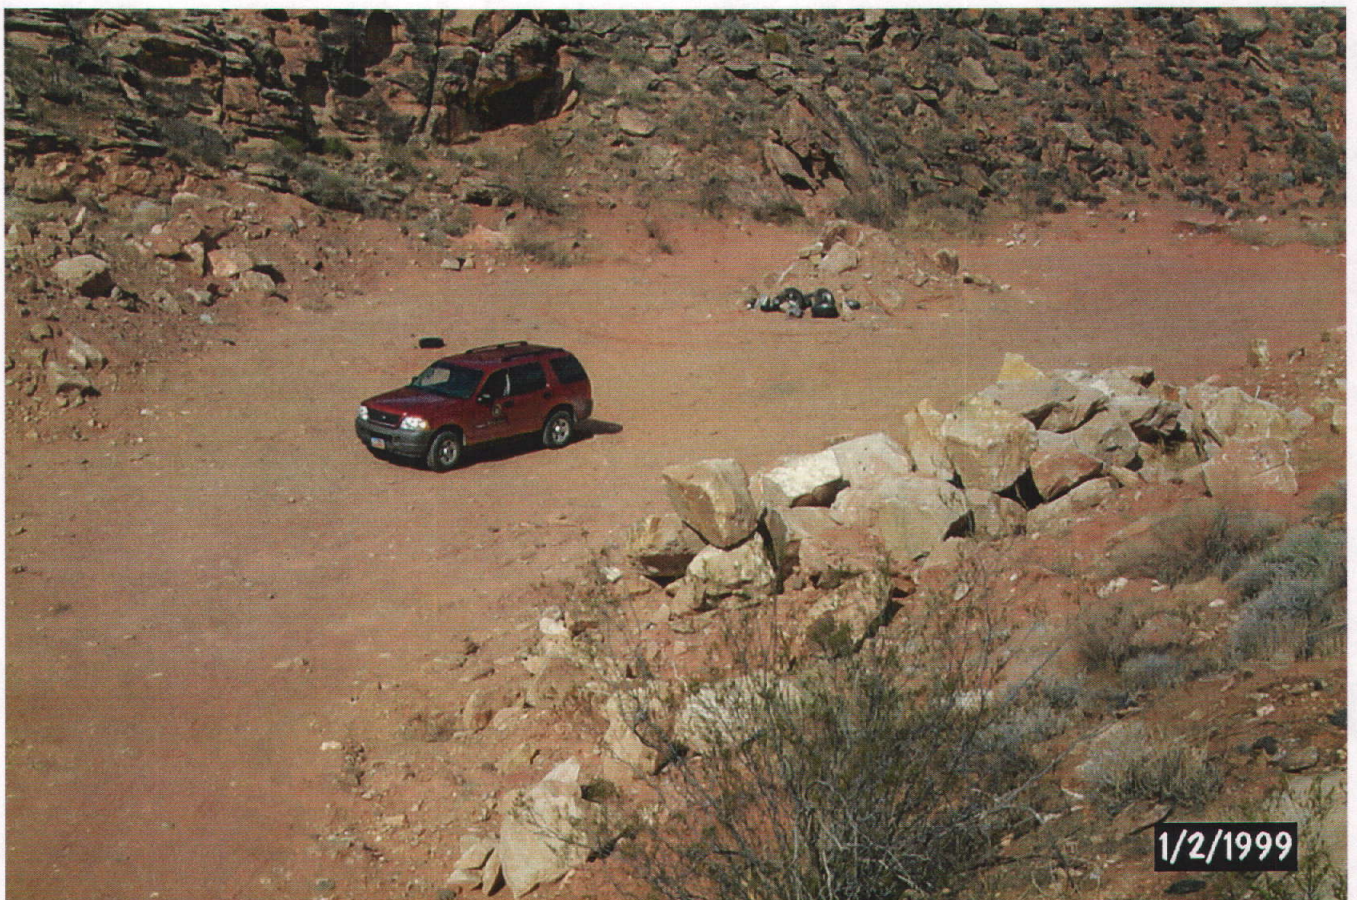
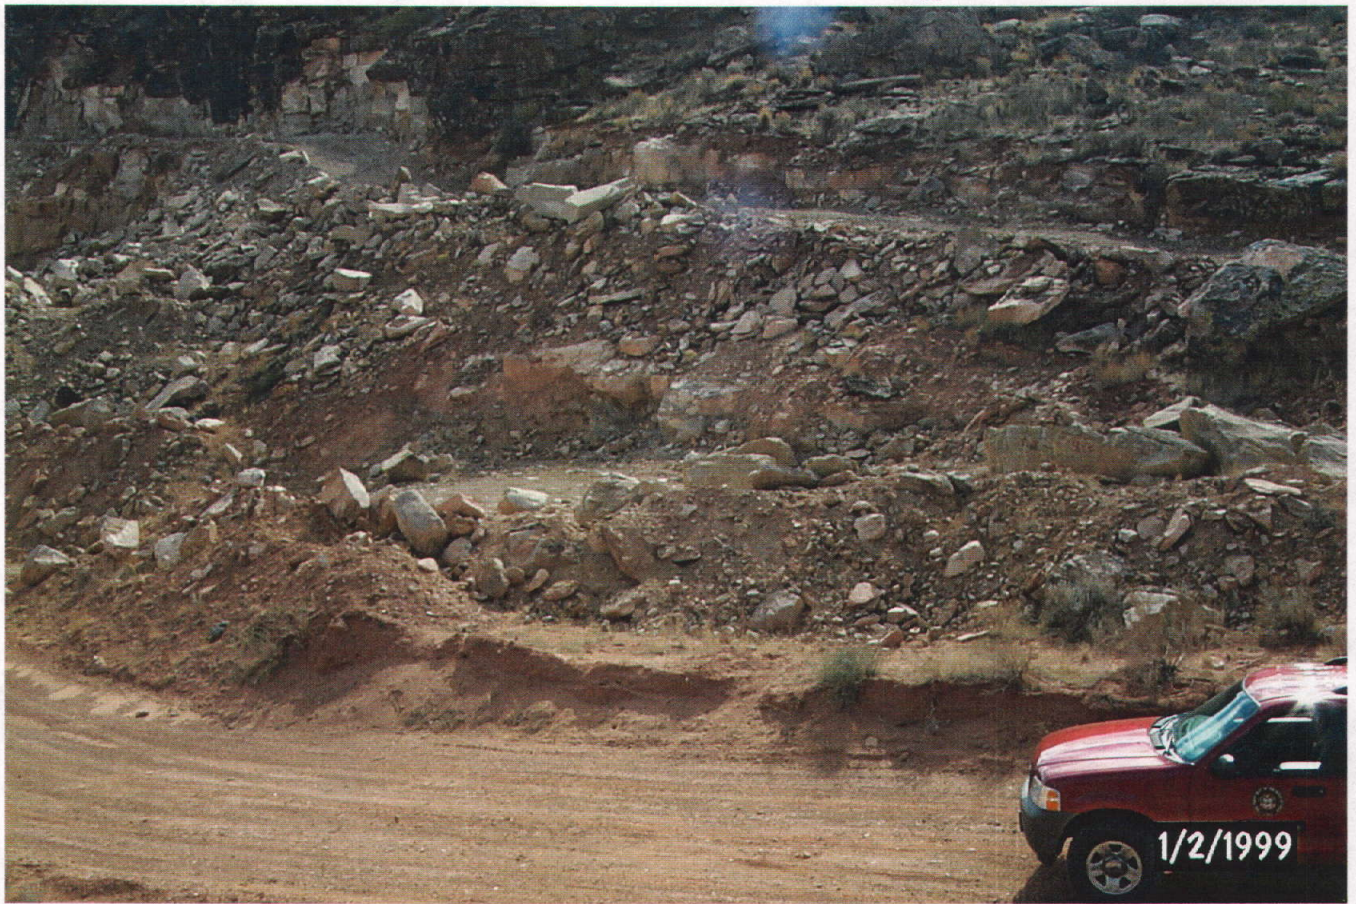
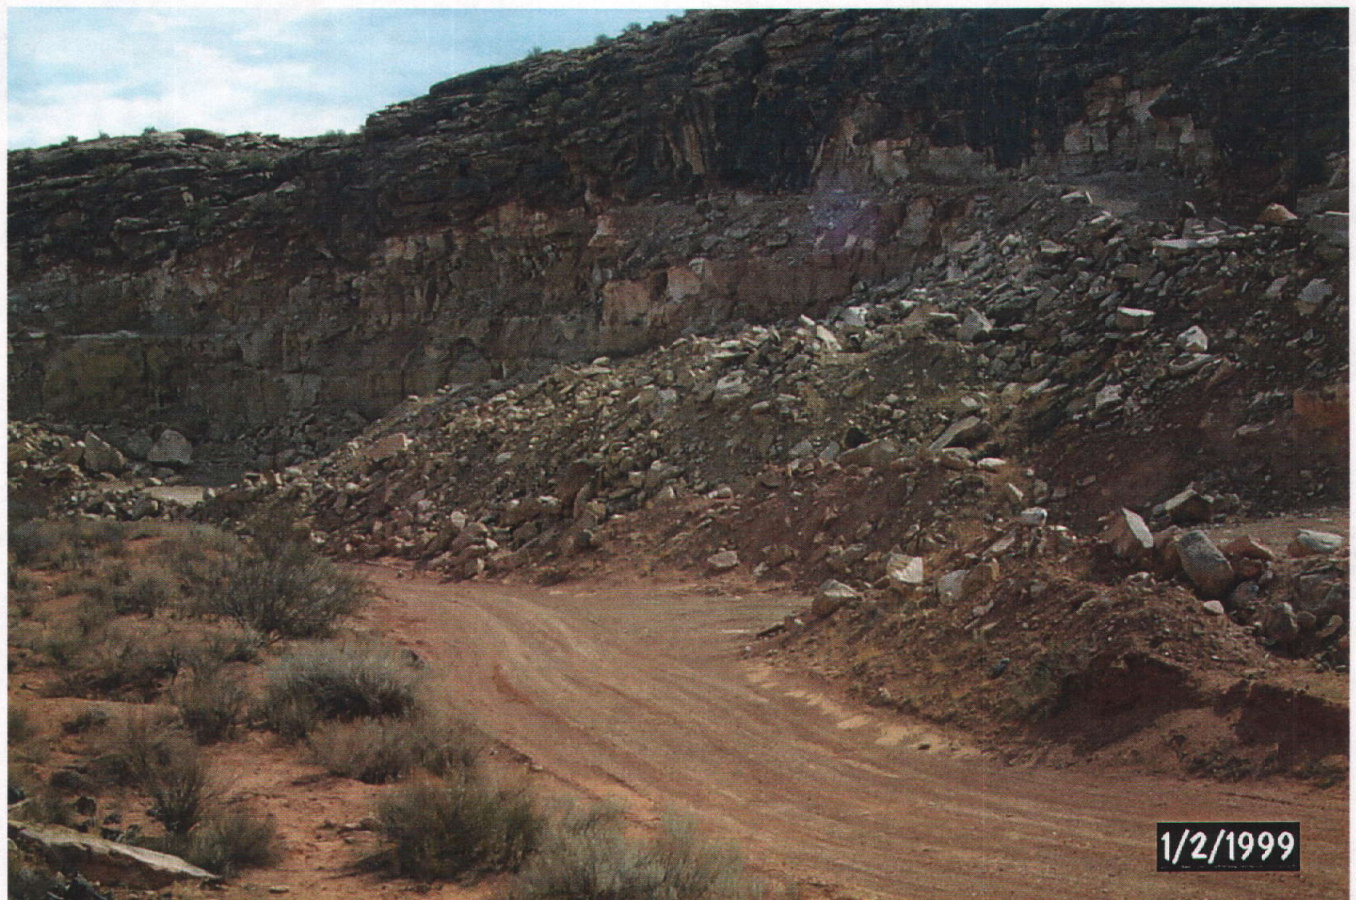
The upper quarry at the site has not changed much since the April 16, 1999 inspection. The dump located below this portion of the site has not been reclaimed and some quarrying activities have taken place on the west wall of the wash above the dump. The dump is about the same size as it was on April 16, 1999. There was no sign that any attempt had been made to reclaim the dump.

Pictures were taken of the site, the date on the pictures is incorrect due to a battery failure in the camera.

This site appears to be very near to the five acre limit for a small mine permit. I will take the GPS with me on the next trip to St. George and will survey the site for an exact acreage figure.
